# Manhole Inspection Summary

Manhole # S3500\_044MH

Insp Date: **1/24/07 11:59 AM**

**Location** Address: **340 23 1/2 ST**

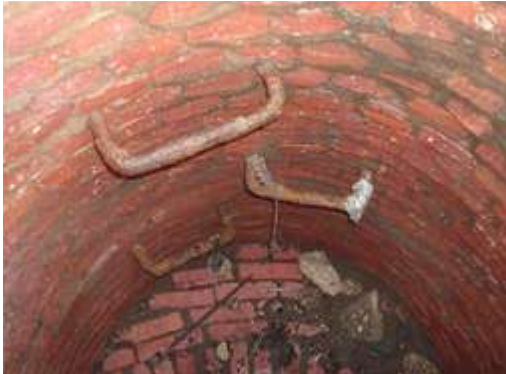
Defect

**Steps** Count: **3** Missing: **0** ☐ Corroded

**Surcharge** ☒ **Evidence Of Surcharge** Depth: **2** (ft.) ☐ Active Surcharge Present

CORRODED STEPS, EVIDENCE  
SURCHARGE ON STEPS

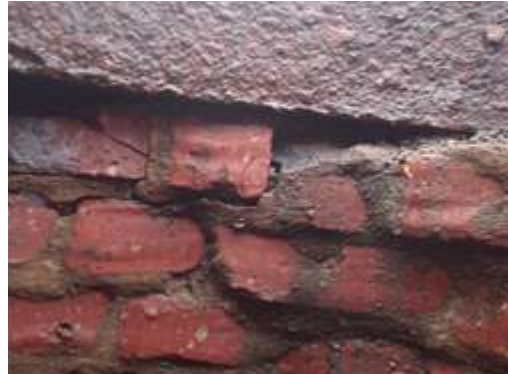
Defect

**Chimney / Frame Adjustment** ☒ Exists Material: **Brick** ☐ Parged Height: **6** (in.)

Condition: ☐ Sound ☐ Cracked ☐ Root Intrusion ☐ Loose Brick ☒ **Deteriorated**

DETERIORATION OF CHIMNEY

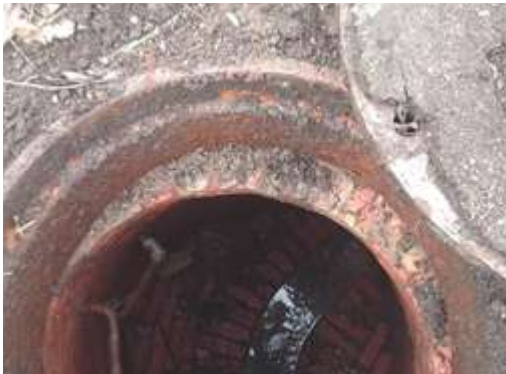
Defect

**Frame** Offset: **3** (in.) Condition: ☒ Sound ☐ Cracked ☐ Leaks

FRAME OFFSET

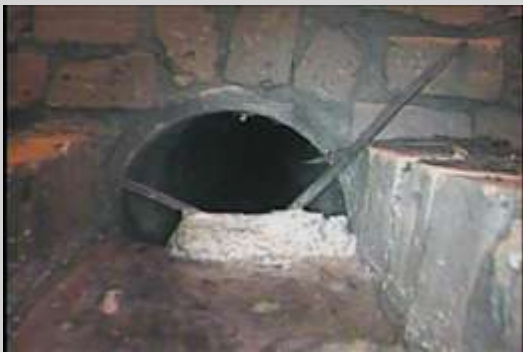
### 8 in. Circular Gravity Sewer Pipe Out @ 12 O'Clock

Deposits: ☐ None ☐ Mud ☐ Sludge ☒ **Debris** ☐ Grease

Silt Depth: **5** (in.) Deposits Extent: **Medium**

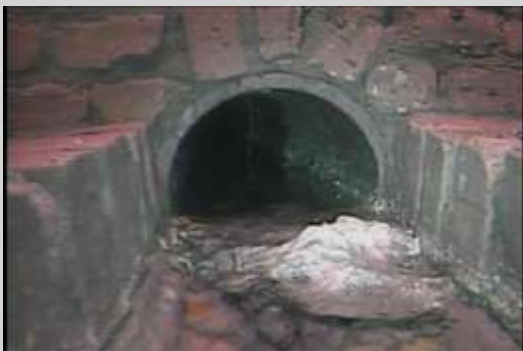
### 8 in. Circular Gravity Sewer Pipe In @ 4 O'Clock

Deposits: ☐ None ☐ Mud ☐ Sludge ☒ **Debris** ☐ Grease

Silt Depth: **3** (in.) Deposits Extent: **Medium**
